School Building Authority of West Virginia
GRANT COUNTY NEEDS PROJECT – COUNTYWIDE ENERGY MANAGEMENT PLAN

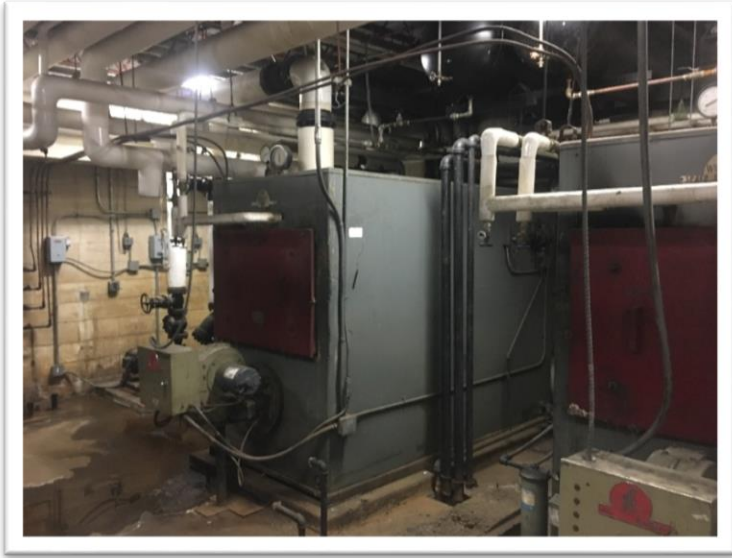
The existing boilers are fifty years old and have outlived their life expectancy.

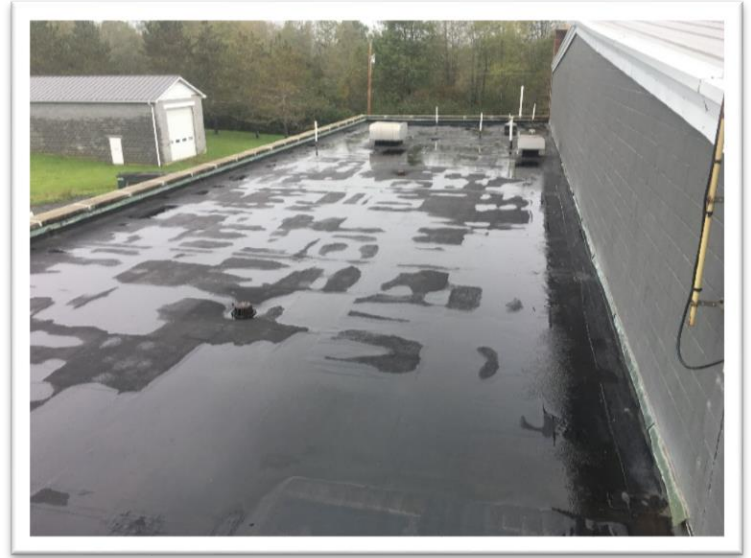
The existing roof has low spots and allows standing water. Leaks are found throughout the facility causing damage ceiling tile.

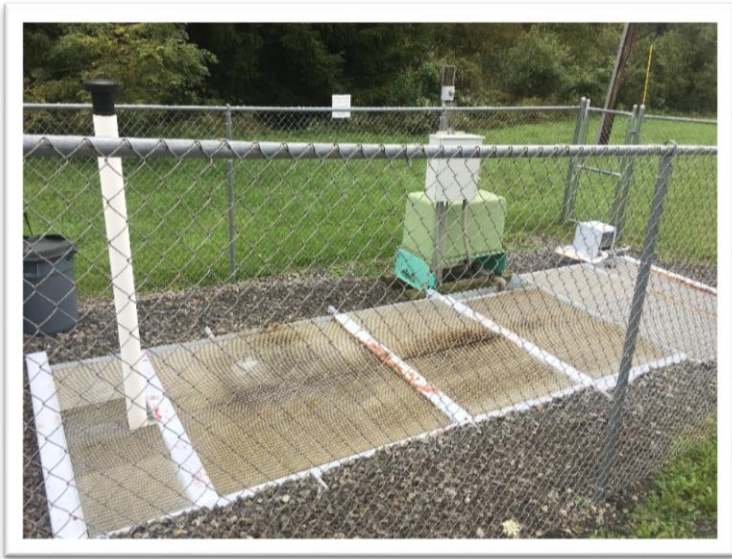
The existing water treatment plant is over forty years old and multiple leaks due to rusting equipment.

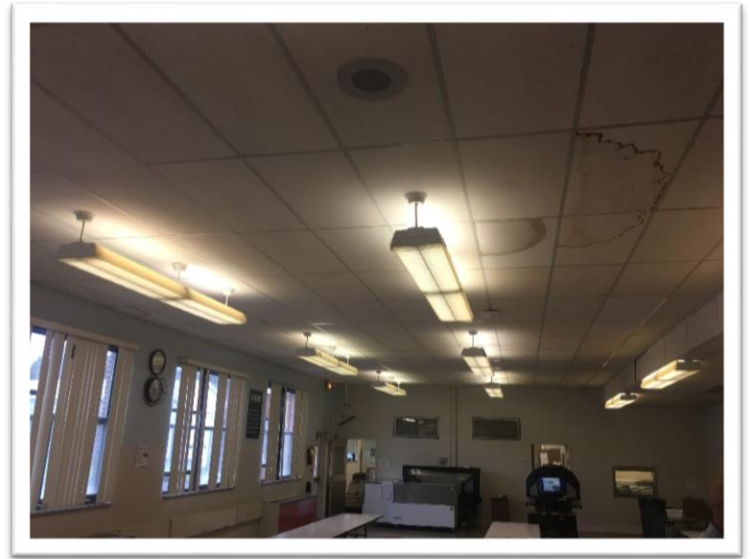
The existing lighting is outdated and inefficient. Ceilings are old and damaged from leaks in the roof.
