School Building Authority of West Virginia
SUMMERS COUNTY – ROOF REPLACEMENT AT SUMMERS COUNTY MS

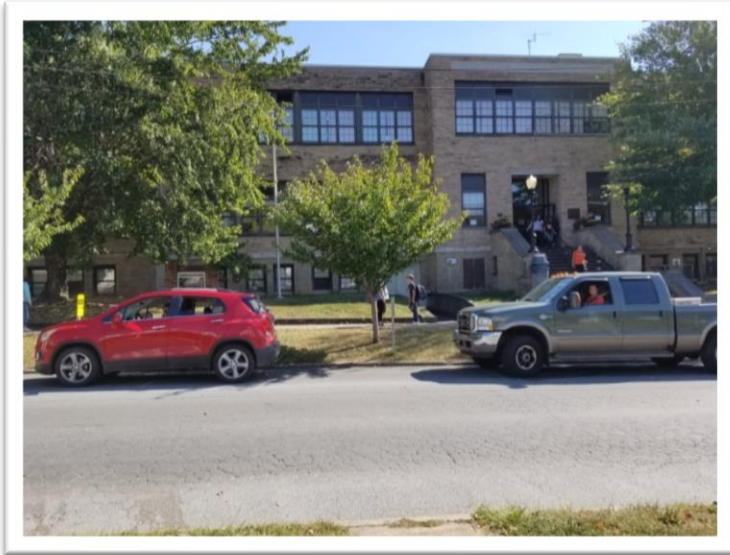
Street view of Summers County MS showing mold stains from moisture issues both above and below the windows. This is typical throughout the facility.

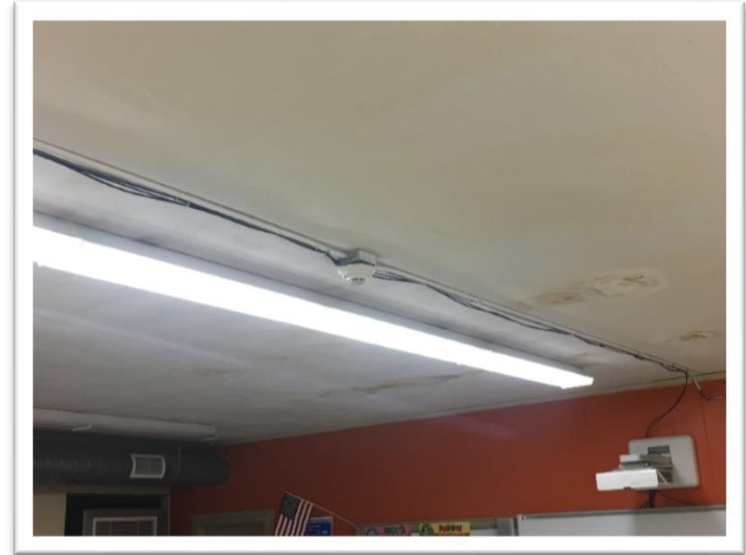
Roof leaks are common throughout the facility and cause regular disruptions to the students during rain events.

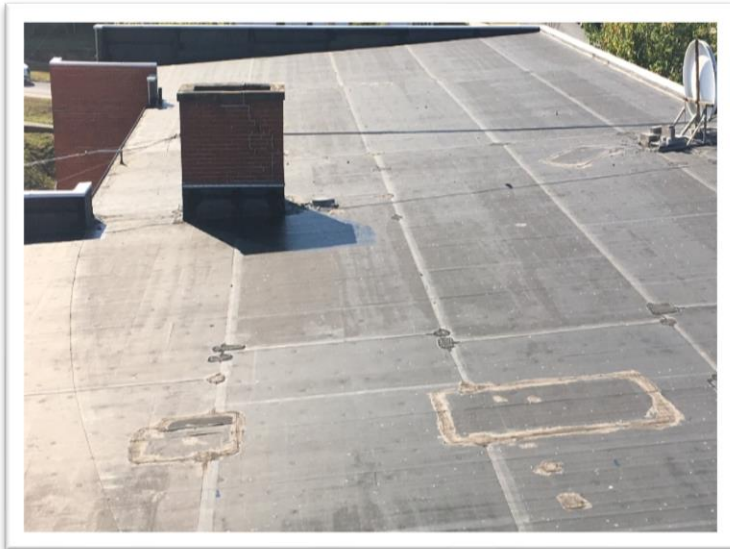
Example of the extensive patching and repairs performed to the EPDM roofing by the county maintenance staff in an attempt to slow roofing leaks.

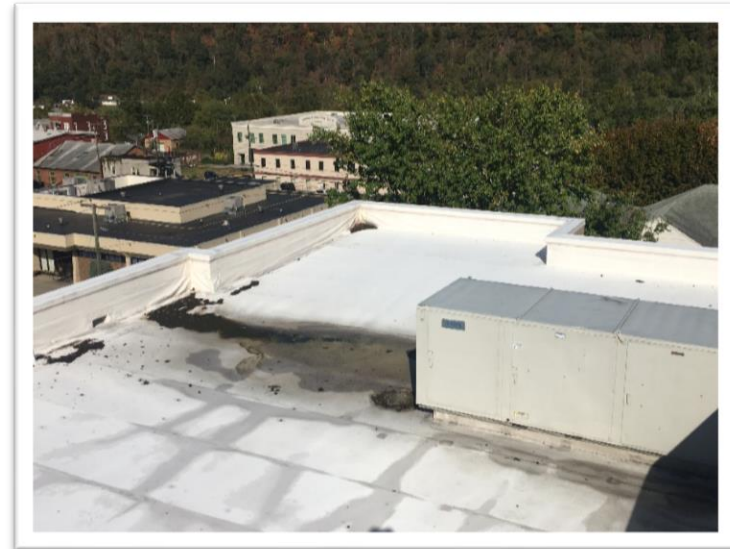
Ponding water and failing wall flashings in the Thermoplastic roofing. This area can not be patched due to the type of roofing membrane used.
