School Building Authority of West Virginia
BARBOUR COUNTY- PHILIPPI ELEMENTARY ROOF REPLACEMENT

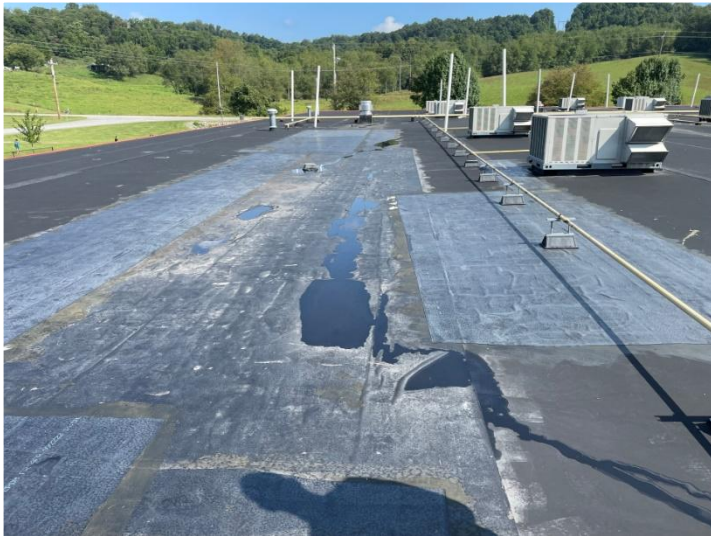
Large patches on roof to fix leaks.

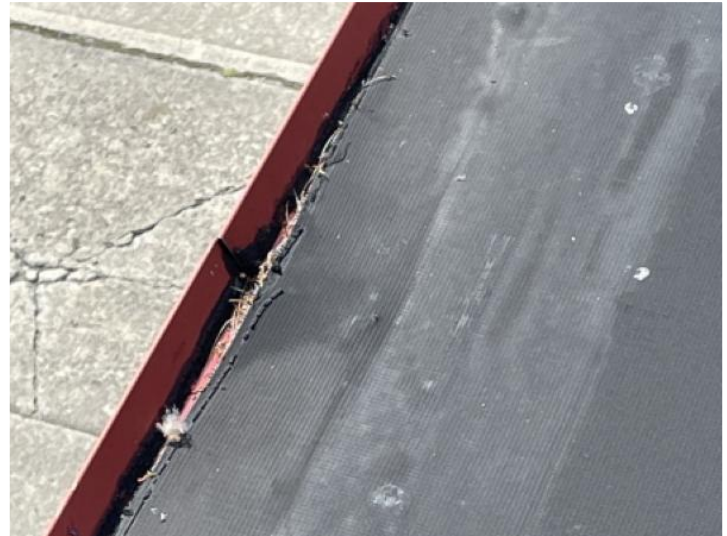
Frayed edge of EPDM at roof's edge where water is running down into building.

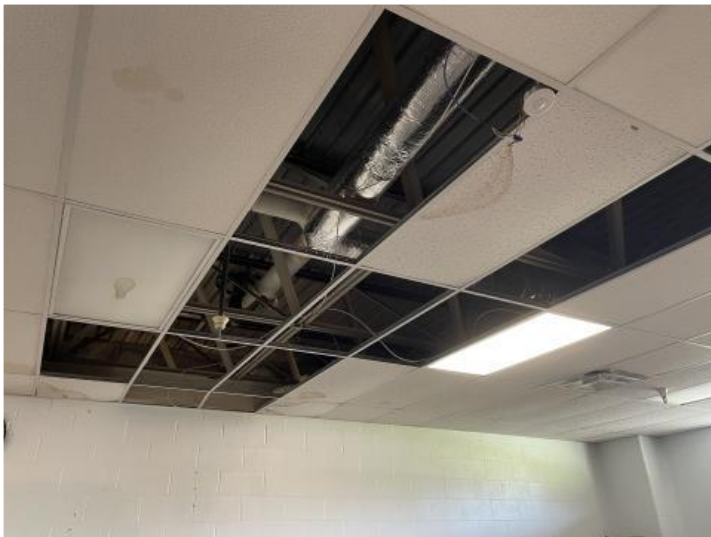
Damaged tile in classroom where maintenance personnel are tracking gutter and downspout failure.

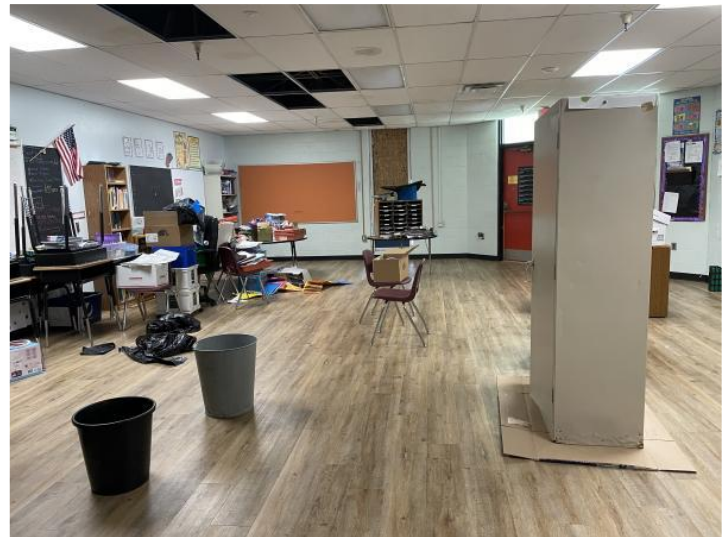
Classes moved to the next room while the room dries out.
