## School Building Authority of West Virginia MINERAL COUNTY – NEW ROOFING AND HVAC REPLACEMENT AT KEYSER AND FRANKFORT MS

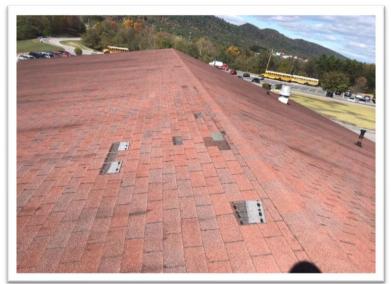
Typical roof area at Frankfort MS showing shingles that are failing in many locations around the facility.

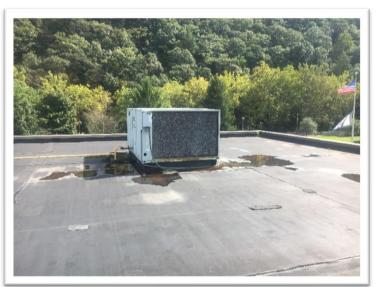
Typical roof top unit and example of ponding water on the roof of Keyser Middle School
